Multi-Family Building Energy Audit

Main Street Apartments
123 Main St.
Smalltown, PA 12345

February 2, 2011

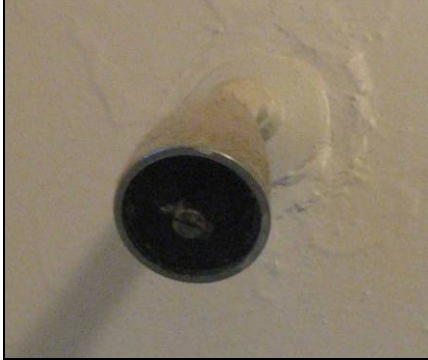
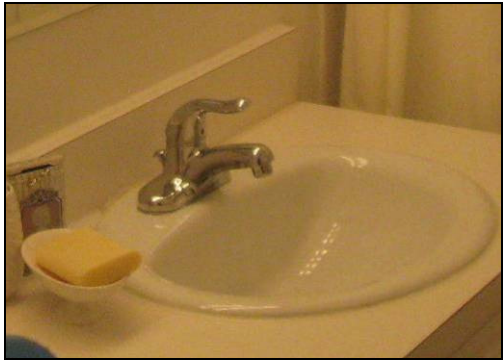
ECM #1	Low Flow Showerheads and Faucet Aerators	
<i>Rationale:</i>	<p>Much of the water used in a multifamily building flows through showerheads and faucet aerators. The current federal mandate for these devices is a maximum flow rate of 2.5 gallons per minute (gpm). Most of the faucet aerators in the building are 2.2 gpm models. Some of the showerheads have been replaced with 1.6 gpm models, but others are likely to be aging and use 3.0+ gpm.</p> <p>High efficiency models are available that can reduce this flow well below even the current federally mandated maximum levels. This will reduce both water consumption and water heating energy use.</p>

<i>Proposed Implementation Method:</i>	<ol style="list-style-type: none"> 1. Replace all shower heads with 1.6 or 1.75 gpm versions. One suitable model is the Niagara Conservation Earth Massage N2917CH, which provides a variable spray pattern and reliable performance at a reasonable cost. 2. Replace all faucet aerators with 1.5 gpm versions.

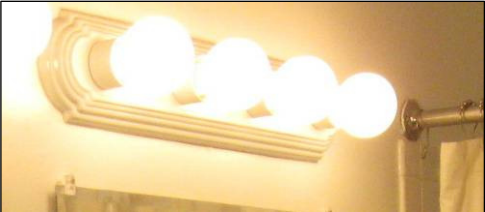
ECM #2	Lighting Upgrade Package
<p><i>Rationale:</i></p>	<p>Much of the common area lighting at Main Street Apartments has been upgraded to improve energy efficiency. In the apartments, however, most of the fixtures are fitted with inefficient incandescent lamps that consume more electricity than necessary. Replacing them with compact fluorescent lamps (CFL's) will dramatically lower the electricity consumption of the building while providing comparable light levels and quality.</p> <ol style="list-style-type: none"> 75+% of the observed fixtures in the visited apartments use incandescent lamps. <div data-bbox="917 508 1399 718" data-label="Image">

1. Replace all of the incandescent lamps in the exterior and hard-wired apartment fixtures with compact fluorescent lamps (CFL's). 13-15W lamps will be adequate for all locations except kitchens and bathrooms, which are often lit to low levels. 23W lamps should be installed in these locations.

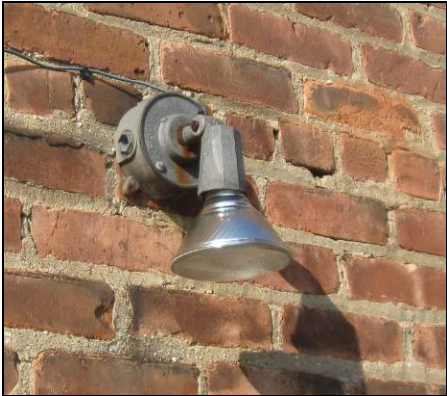
</div> Three fixtures on the exterior of the building use incandescent lamps. (In flood fixtures and at the entry to the manager's apartment.) <div data-bbox="703 827 1146 1220" data-label="Image">

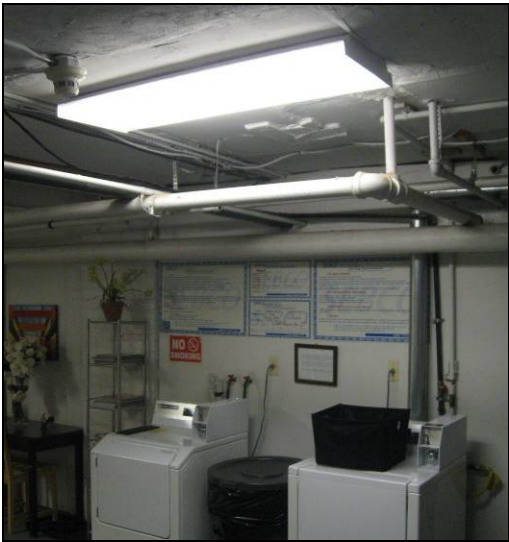
</div> The light fixtures serving the laundry room are controlled by manual switches. Therefore, these lights are often left on when this space is unoccupied. <div data-bbox="672 1310 1177 1848" data-label="Image">

2. Install 3-way, switch-mounted occupancy sensors to control the lights in the laundry room.

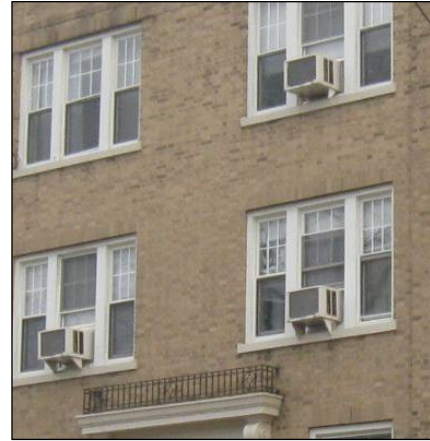
- Window air conditioners appear to remain installed during the heating season, allowing a significant amount of air to move between the building and outdoors.

<p><i>Proposed Implementation Method:</i></p>	<ol style="list-style-type: none"> 1. Install heavy duty weather strips and sweeps on the side entry doors and the roof access doors. Alternatively, replace these un-insulated wood doors with insulated, pre-hung units. 2. Seal the skylight cap vents with backer rod and caulk. 3. Assist the residents in removing all window air conditioning units for the heating season. 4. Install new weather strips and center astragal seals on the main entry doors. 5. Seal all penetrations from the boiler room into the adjacent spaces. This includes installing a weather strip on the door and sealing all gaps in and above the walls with spray foam. 6. Seal the dumbwaiter shafts at the top floor ceiling level (if possible) and at the basement ceiling level with Thermax rigid sheet insulation and spray foam. Appropriate steps must be taken to deal with dryer exhaust that enters one of these shafts from a top floor apartment. 7. Have a BPI certified air sealing contractor seal all penetrations through the top floor ceiling plane, including the entire perimeter, partition wall top plates, and any plumbing or chimney chases. 8. Install insulation and weather stripping on each attic hatch.

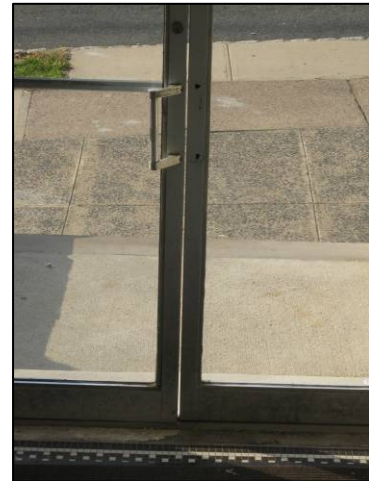
- The weather strip and astragal seals on the main entry doors are worn and in need of replacement.

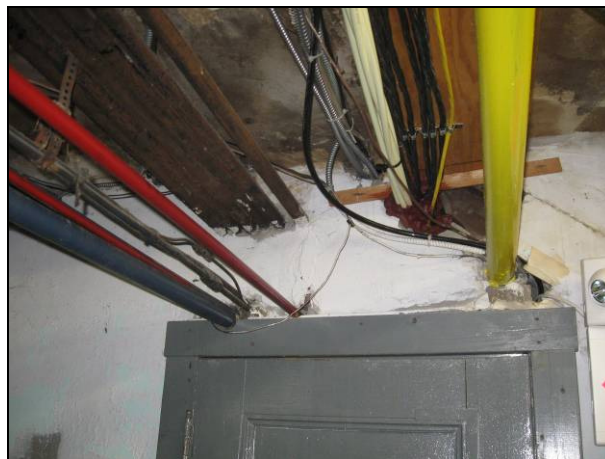
- The boiler room is highly vented to the exterior to provide combustion air to the boilers. Therefore, it should be well isolated from the rest of the building. However, the door to the laundry room lacks a weather strip and the walls to the adjacent rooms are not well sealed.

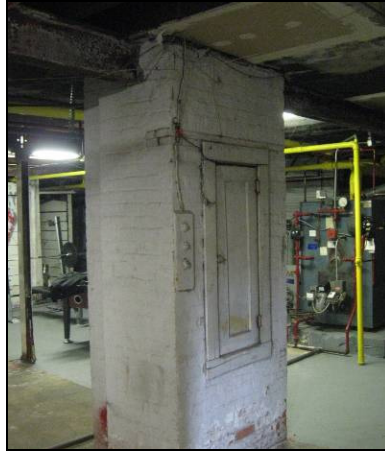
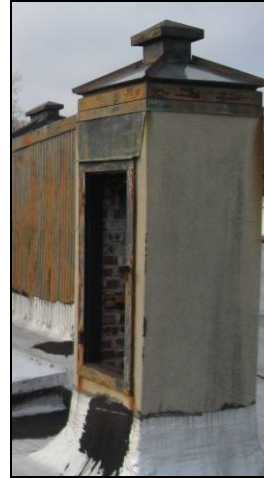
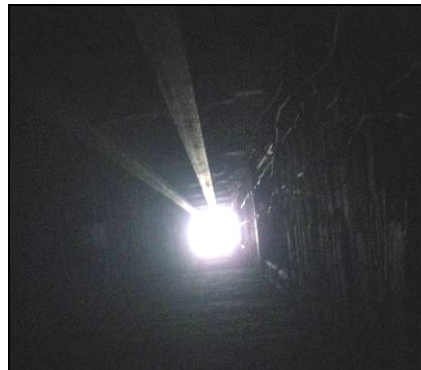
- Four abandoned dumbwaiter shafts run from the basement up through the roof. They have been penetrated in numerous locations to facilitate wiring changes. These shafts act like chimneys, allowing cool basement air to flow in, absorb heat from the building, and exit into the attic or at the poorly sealed caps above the roof level. One shaft is wide open above the roof level, and one is used to vent a dryer in Apartment 12.

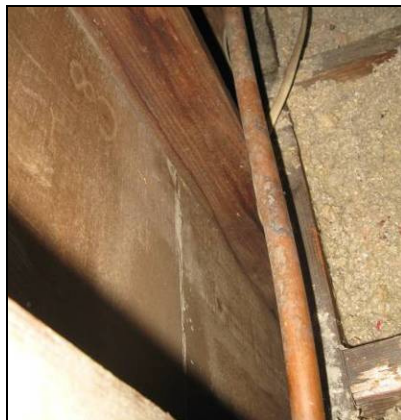
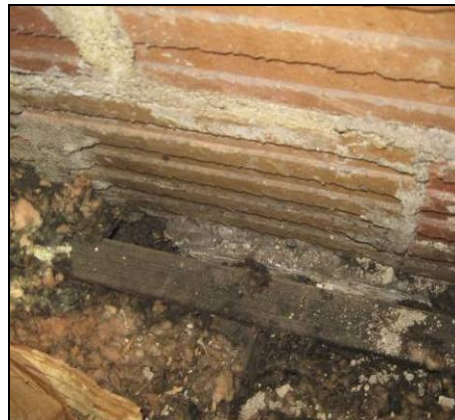
- The attic has been insulated but not air-sealed. Numerous air leakage points exist, particularly between the brick structure and wall framing at the exterior perimeter and around the stairwells. Additional leakage points exist at the tops of partition walls and around the chimney and dumbwaiter chases.

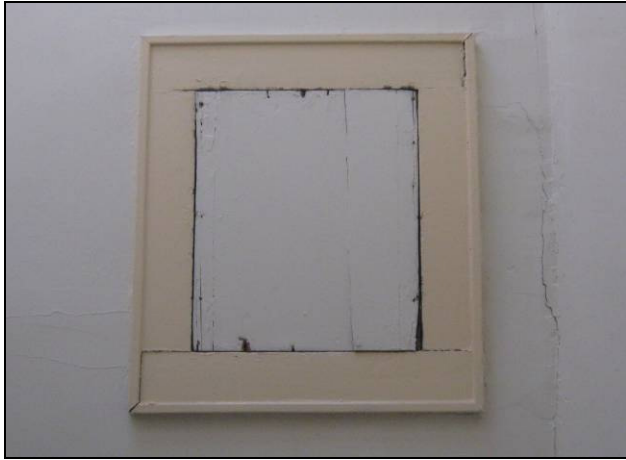
<ul style="list-style-type: none"> An attic hatch is located at the top of each stairwell. Neither is insulated or sealed with weather strip. They allow a substantial amount of air to move between the attics and stairwells.

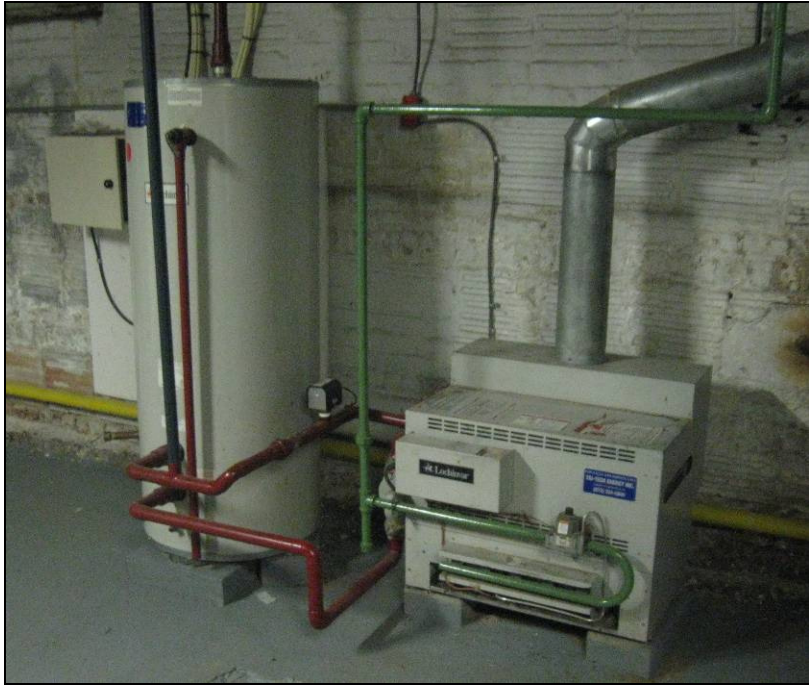
ECM #5	Control Domestic Hot Water Boiler & Pump Based on Tank Temperature	
<i>Rationale:</i>	<p>Domestic hot water is heated in a storage tank by a dedicated boiler. A pump continuously circulates water between the boiler and the tank and the boiler fires when the return temperature is below 140°F. Because room air is always flowing through the boiler and up the chimney, this operational strategy results in continuous standby losses as heat flows from the hot water through the boiler heat exchanger and up the chimney.</p>

<i>Proposed Implementation Method:</i>	<ol style="list-style-type: none"> 1. Install an aquastat in the port specifically intended for this purpose on the storage tank. 2. Set the aquastat to 130°F, and wire it so the boiler and circulator pump only run when the temperature in the tank falls below the set point.

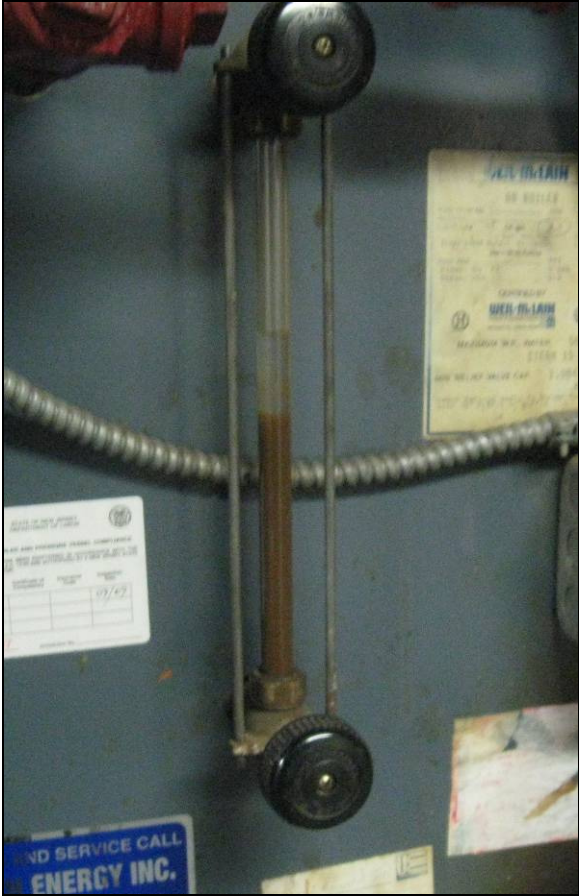
ECM #6	Flush Boiler	
<i>Rationale:</i>	<p>Visual inspection at the boiler sight glass indicates that a significant amount of sediment has accumulated in the boiler. This sediment can slow heat transfer through the heat exchanger and plug valves or air vents.</p>

<i>Proposed Implementation Method:</i>	<p>Thoroughly flush the boiler whenever the water in the boiler sight glass is either cloudy or significantly discolored.</p>	
Estimated Implementation Cost:	\$ 204	
Estimated Annual Energy Savings:	\$ 50

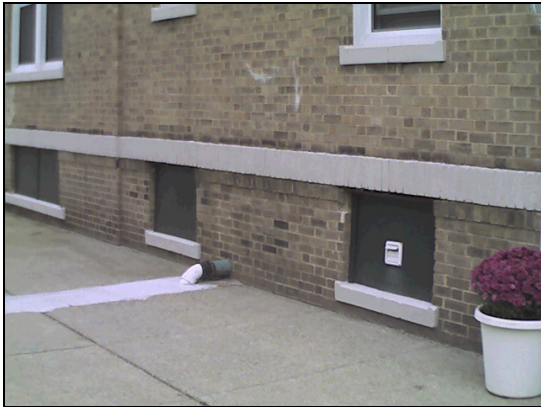
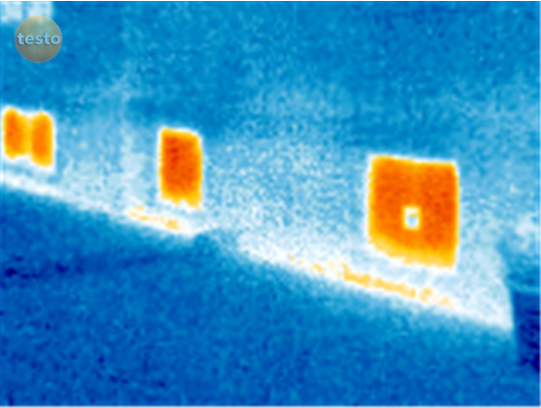
ECM #7	Insulate Boarded Basement Windows	
<i>Rationale:</i>	<p>Based on thermal imaging, the boarded windows in the basement laundry room are a large source of heat loss. They can be insulated with relative ease.</p> <div style="text-align: center;">

</div>	
<i>Proposed Implementation Method:</i>	Install 1-2" thick rigid foam insulation on the interior of the boarded windows and seal the perimeter of the foam to the window frames with caulk.	
Estimated Implementation Cost:	\$ 246	
Estimated Annual Energy Savings:	\$ 54

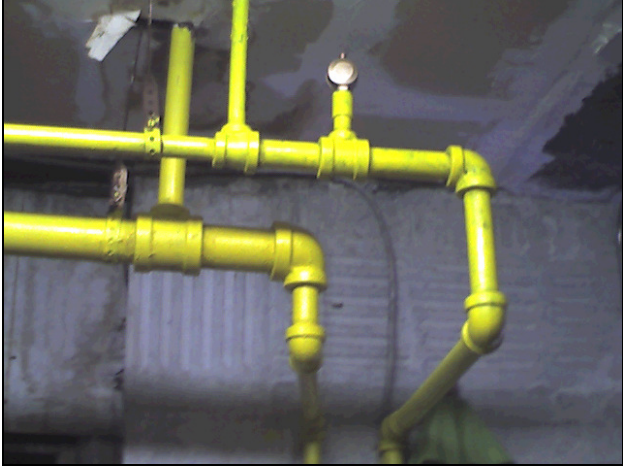
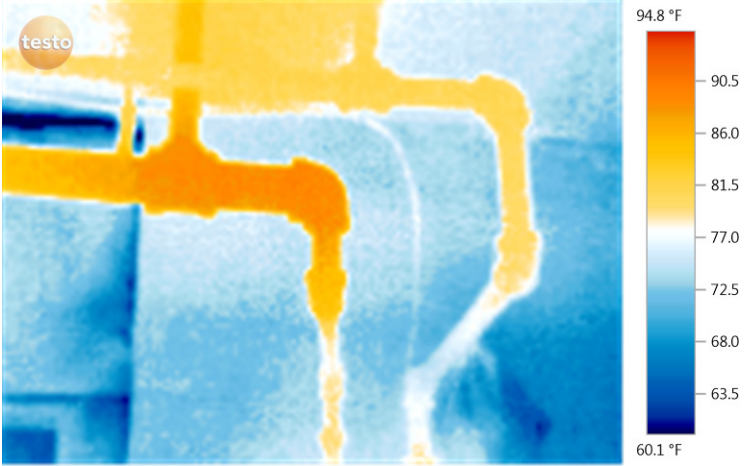
ECM #8	Insulate Steam Pipes in Boiler Room	
Rationale:	<p>None of the steam pipes in the boiler room are insulated. These pipes are very hot and lose a significant amount of heat to the surrounding space. The boiler room is intentionally vented to provide combustion air to the boilers. Therefore, much of the heat from the steam pipes is wasted warming air that flows into the room, through the boilers, up the chimney, and out of the building.</p> <div style="text-align: center;">

</div>	
Proposed Implementation Method:	<p>Install R-5 fiberglass insulation on all steam lines in the boiler room. It should cover all straight sections, elbows, and tees.</p> <p>Both steam lines and condensate return lines should be insulated where practical.</p>	
Estimated Implementation Cost:	\$ 1305	
Estimated Annual Energy Savings	\$ 119
