Multi-Family Building Energy Audit

Main Street Apartments
123 Main St.
Smalltown, PA 12345

February 2, 2011

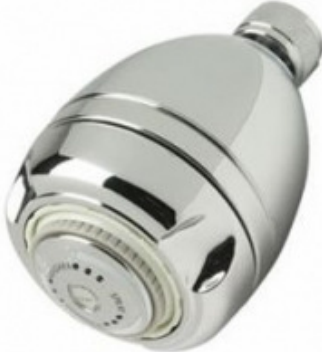
ECM #1	Low Flow Showerheads and Faucet Aerators	
<i>Rationale:</i>	<p>Much of the water used in a multifamily building flows through showerheads and faucet aerators. The current federal mandate for these devices is a maximum flow rate of 2.5 gallons per minute (gpm). Most of the faucet aerators in the building are 2.2 gpm models. Some of the showerheads have been replaced with 1.6 gpm models, but others are likely to be aging and use 3.0+ gpm.</p> <p>High efficiency models are available that can reduce this flow well below even the current federally mandated maximum levels. This will reduce both water consumption and water heating energy use.</p>

<i>Proposed Implementation Method:</i>	<ol style="list-style-type: none"> 1. Replace all shower heads with 1.6 or 1.75 gpm versions. One suitable model is the Niagara Conservation Earth Massage N2917CH, which provides a variable spray pattern and reliable performance at a reasonable cost. 2. Replace all faucet aerators with 1.5 gpm versions.

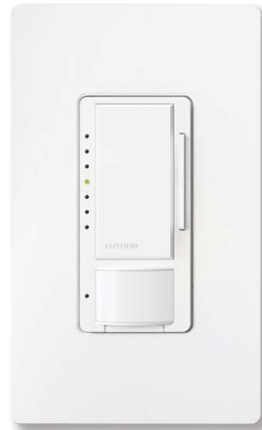
ECM #2	Lighting Upgrade Package
<p><i>Rationale:</i></p>	<p>Much of the common area lighting at Main Street Apartments has been upgraded to improve energy efficiency. In the apartments, however, most of the fixtures are fitted with inefficient incandescent lamps that consume more electricity than necessary. Replacing them with compact fluorescent lamps (CFL's) will dramatically lower the electricity consumption of the building while providing comparable light levels and quality.</p> <ol style="list-style-type: none"> 75+% of the observed fixtures in the visited apartments use incandescent lamps. <div data-bbox="917 508 1399 718" data-label="Image">

1. Replace all of the incandescent lamps in the exterior and hard-wired apartment fixtures with compact fluorescent lamps (CFL's). 13-15W lamps will be adequate for all locations except kitchens and bathrooms, which are often lit to low levels. 23W lamps should be installed in these locations.

2. Install 3-way, switch-mounted occupancy sensors to control the lights in the laundry room.
